Manhole Inspection Summary

Manhole # S27I__041MH

Insp Date: **5/27/08 1:06 PM**

Location Address: **855 Hayes St**

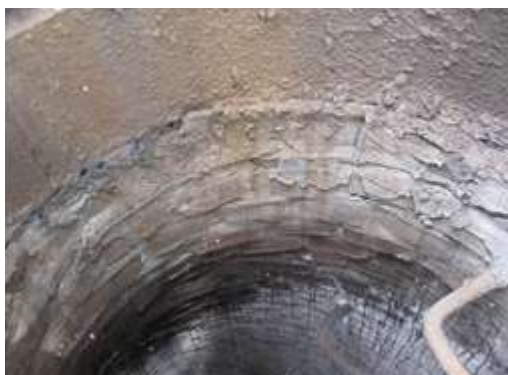
Defect 3

☒ **Leaks**

Infiltration: ☐ None ☐ Joint ☐ Cracks ☒ **Mortar** ☐ Roots ☒ **Wall**

frame leaks, chimney flow wall, chimney mortar

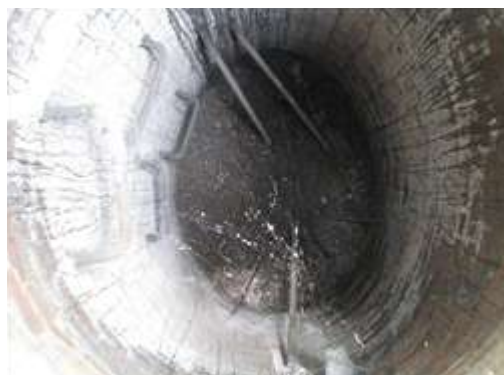
defect 2

Condition: ☐ Sound ☐ Cracked ☐ Root Intrusion ☐ Deteriorated ☐ Leaks ☒ **Debris**

channel and bench cond debris

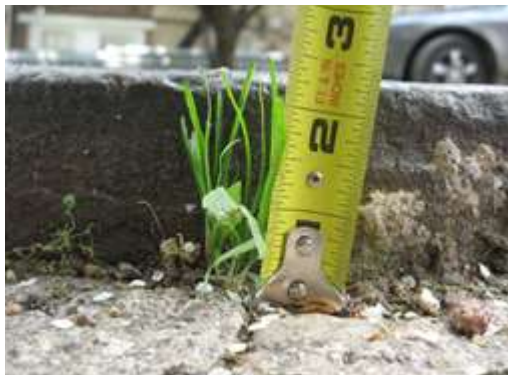
Defect 1

Diameter: **25.** (in.) Length: **0** (in.) Dist A/B Grade: **2.5** (in.)
5

2 inch above grade
